North Marin Water District

2015 MASTER PLAN UPDATE

Final Report

For the Oceana Marin Wastewater System

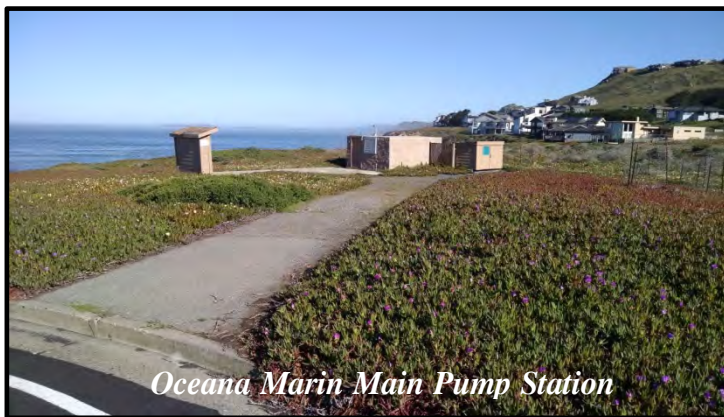
Oceana Marin Main Pump Station

The pump station itself consists of a wet well which is separated from the dry well containing the pumps and electrical work by a wall. There is a grit catchment area in the wet well which is pumped out once a year. Aeration is provided for the sewage in the wet well to keep it fresh and reduce odors.

The dry well part of the pump station contains two sets of rotary lobe pumps; four pumps total. Each set of two pumps are connected in series to be able to overcome the high pumping head. Each pump has a capacity of 100 gallons per minute (gpm) at a discharge pressure of 180 psi. Each set (Set A & B) have two

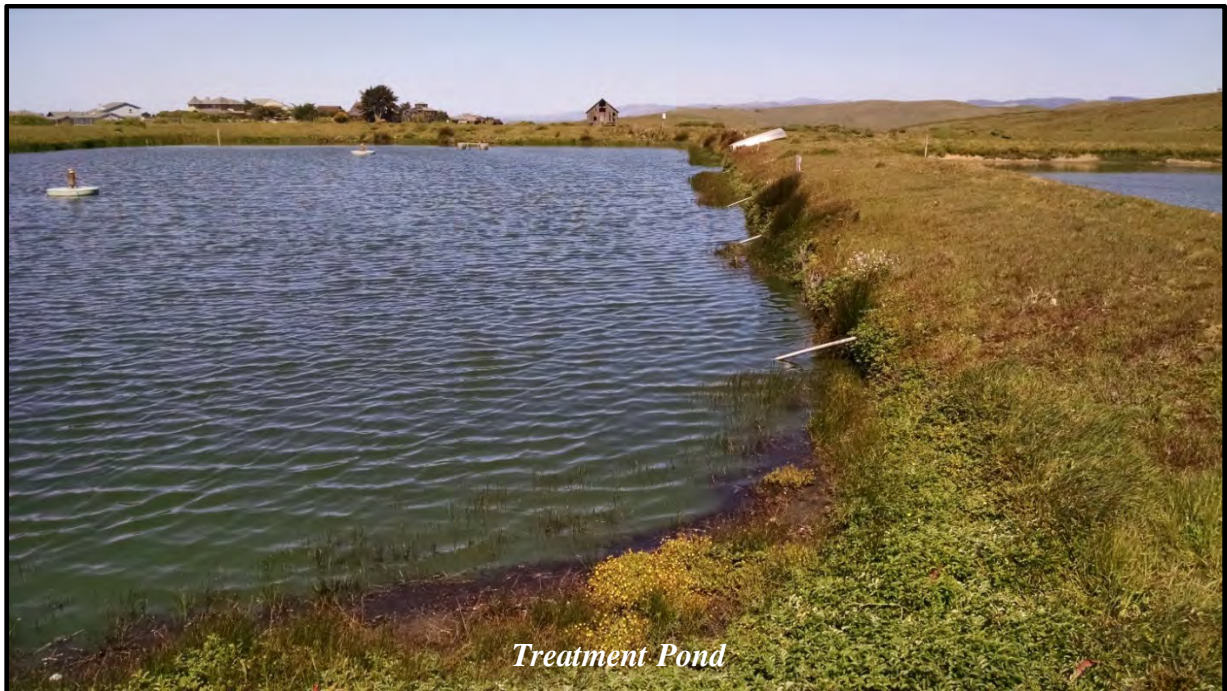
Berm Erosion – Some of the pond berms are eroding, probably from wind generated waves. The wind is primarily from the northwest which means that the southern and east berms are most eroded. The eroded soil has moved into the ponds and reduced their capacity.

If the ponds remain unlined at least the south and east berms should be stabilized. There are different ways to stabilize the banks. Stabilization can be “natural stabilization” by planting vegetation such as willows and cattails. However, this can make the ponds more difficult to maintain and control. An engineering bank stabilization approach can involve placing rip rap over a geofabric or geofabric placed over berms restored with compacted soil.

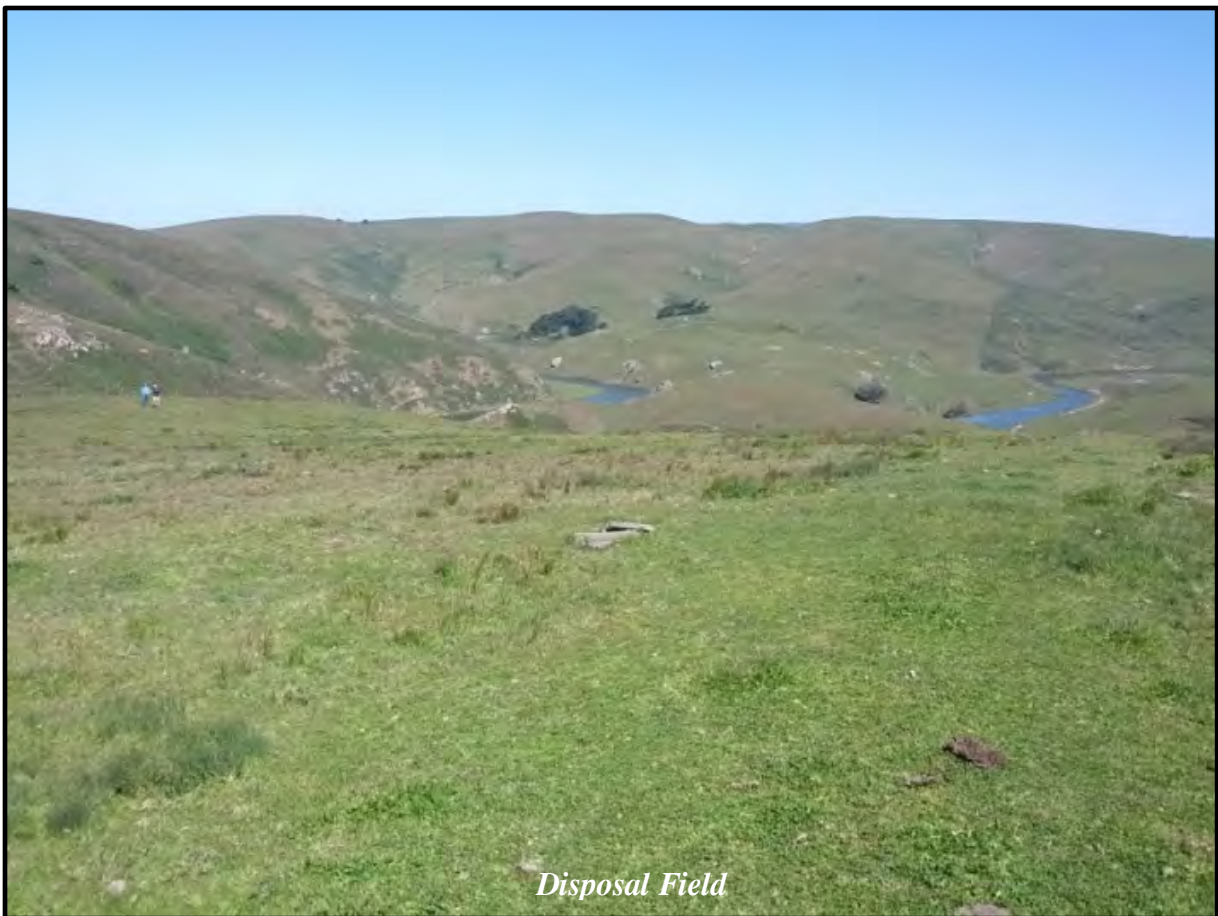
Disposal Field

According to AYS the soils found in the area of the disposal field are not ideal for use as a drain field. However, with proper management this system could last for a very long time, although disposal fields can start to develop issues over time that will need to be addressed.

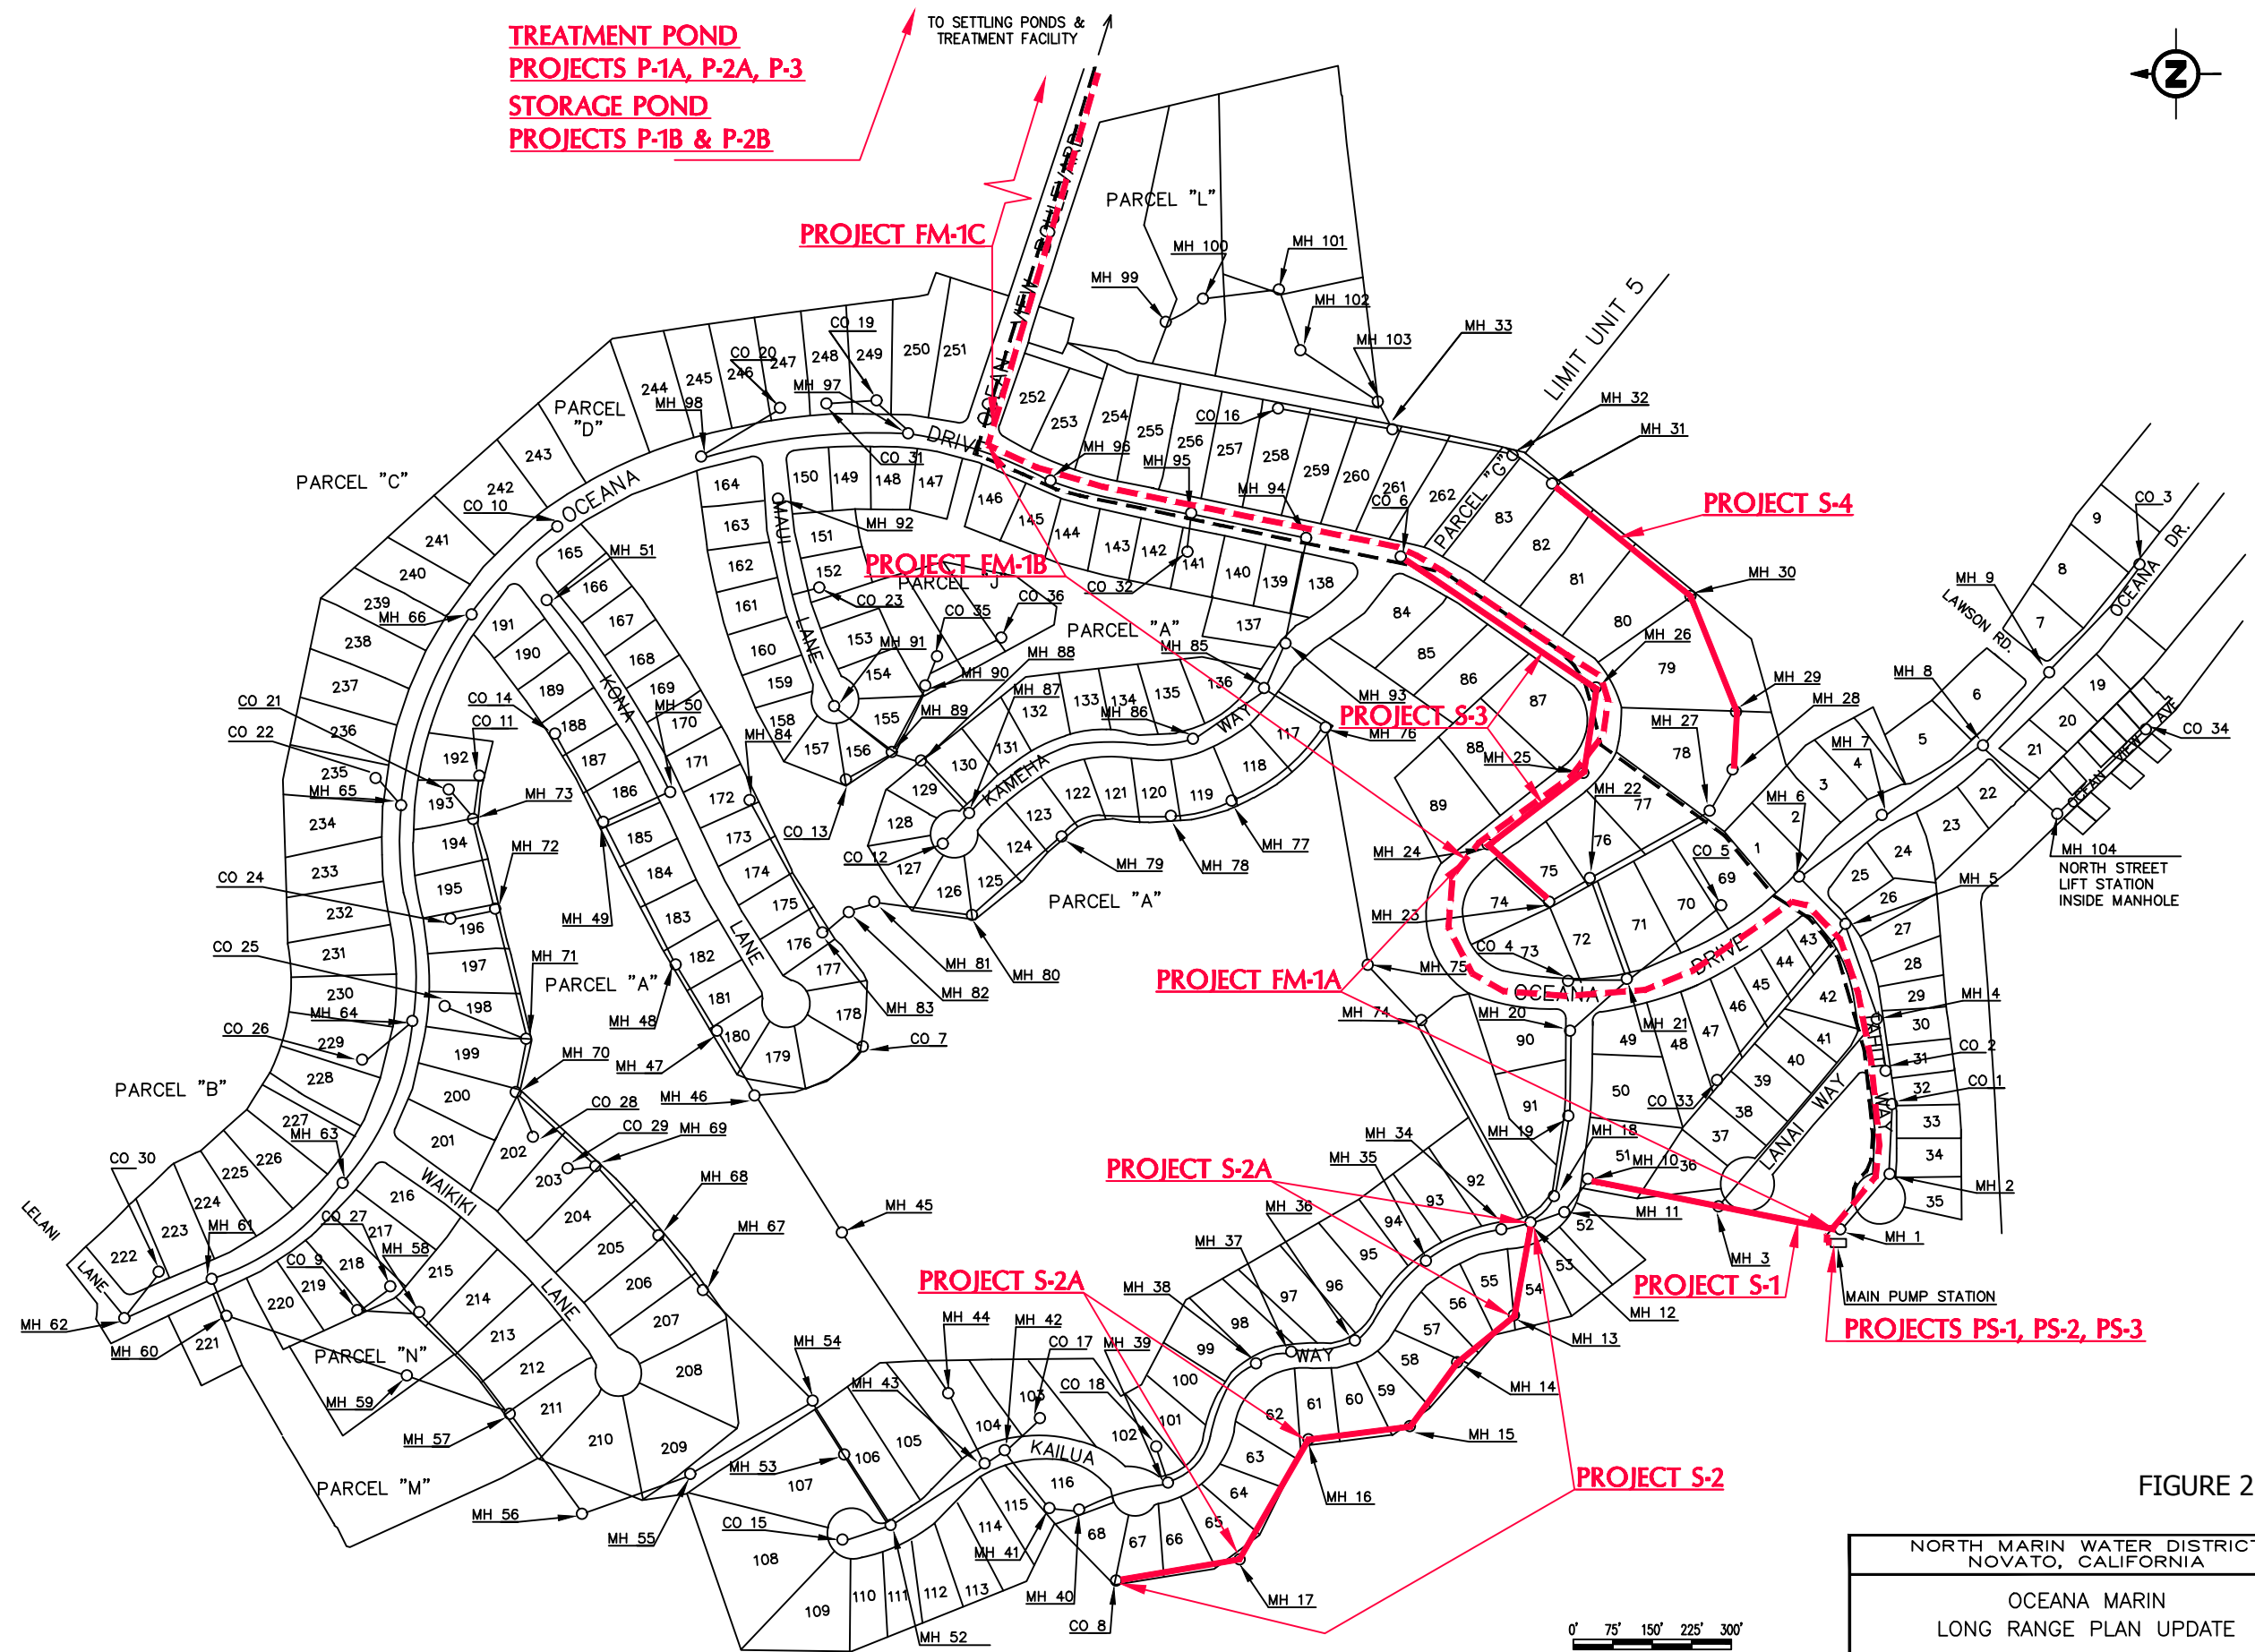
FIGURE 2

Identified Rehabilitation Projects – Based on the CCTV results NMWD routinely undertakes maintenance and repairs as indicated such as cutting roots and digging down and repairing cracks and other isolated defects. Some lines have multiple defects and it is advisable to undertake a capital improvement project to rehabilitate one or more segments of sewers. The following is a list of recommended sewer rehabilitation projects, also shown on Figure 2, together with their estimated costs:

Project S-1 – Pump Station to Kailua Way: MH 1 through MH 3 to MH 10 Kailua Way (477') – The CCTV revealed several sags, infiltration and a separated joint. Part of this line crosses a gully in an above ground pipe. According to the original plans this is 10" diameter ACP except that 40' of ductile iron (DI) pipe was used to span the gully. The plans show a grade of 0.005 which should be adequate. It is unclear why there are sags; either the pipe was improperly laid originally or there has been some ground movement. This line is near the edge of the cliff above the ocean so ground movement is a possibility. If the ground is moving the line may need relocation away from the cliff, which would also probably mean relocating the pump station. A geotechnical investigation would be appropriate to check on the stability of the cliff. This also applies to Project S-2 described below. If the sag is not a major problem and the line is judged to be adequate then it could be CIPP lined. The estimated cost of the CIPP lining of this sewer is given below:

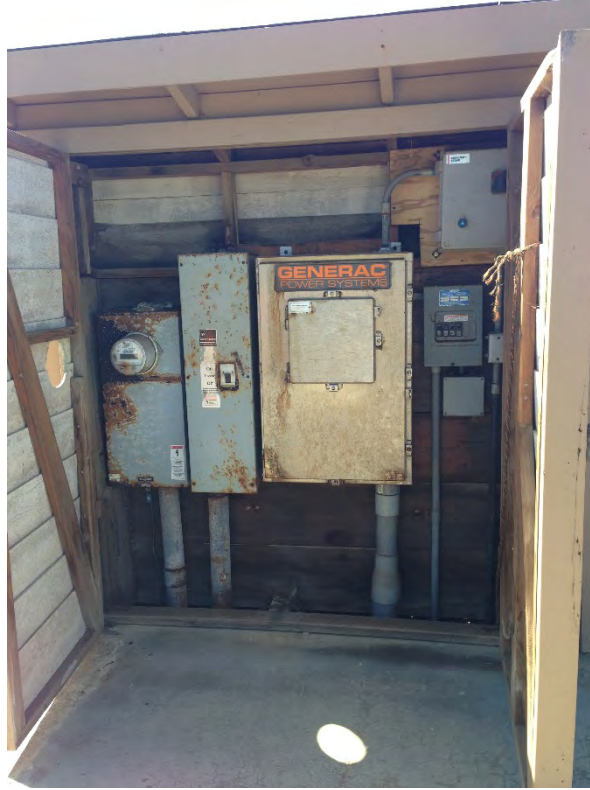
Figure 1: “Doghouse” Shed Interior

The “Doghouse” Shed enclosure is constructed of wood and has not provided adequate protection from the corrosive salt air. Although all of the enclosures within this structure are showing signs of corrosion, the PG&E meter enclosure and main circuit breaker enclosure are the most deteriorated and are both beyond repair. The ATS enclosure, which is fabricated from stainless steel, has some surface corrosion but the enclosure integrity has not been compromised. The small panelboard located in the “Doghouse” Shed includes circuit breakers for powering the standby generator equipment building. This panelboard and the circuit breaker enclosure (i.e. feeder breaker for the main panelboard in the below-grade structure) are starting to show signs of corrosion but the degree of rust appears to be cosmetic at this time.

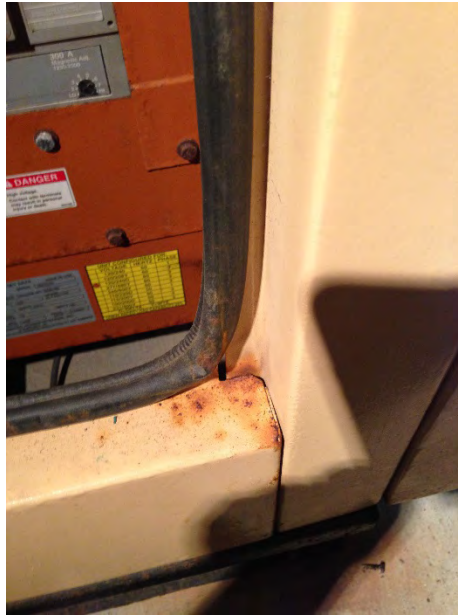
Figure 2: Standby Generator Enclosure Surface Corrosion

The above-grade block building that houses the standby generator appears to have provided a good degree of protection for the interior equipment. There is, however, a ventilation louver located along the north wall of the structure which is designed to gravity-close when the ventilation fan is not running (i.e. the ventilation fan is activated when the generator runs). The louver was found to be hung up in the “open” position due to linkage hardware corrosion. Thus, with the louvers stuck in the “open” position, corrosive salt air has been permitted to freely enter the interior of the block building. This is evidenced by surface corrosion on the standby generator enclosure. NMWD personnel reported that the generator enclosure was recently painted due to corrosion that accumulated when the generator was originally installed outdoors. The interior generator and engine equipment appear to be in good

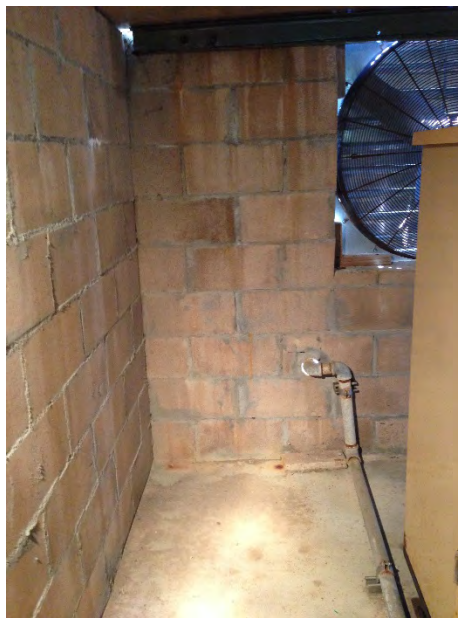
Figure 3: Standby Generator Fuel Piping

The standby generator is fueled by a propane fuel source. During a seismic event, this piping is prone to shearing, particularly at the wall penetration and equipment connection locations.

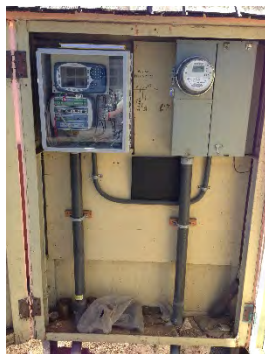
Figure 4: North Street Lift Station Level Controller and PG&E Meter

According to NMWD personnel, it is likely that this lift station will be eliminated due to planned modifications for the existing sewage collection system underground piping. Thus, the below-grade lift station was not entered and inspected. NMWD personnel reported that the station level sensor is installed in the below-grade structure. The existing PG&E metering enclosure and level controller were inspected (i.e. this equipment is currently housed in a wood cabinet adjacent to the street). This equipment is in good condition and NMWD did not report any operational issues.

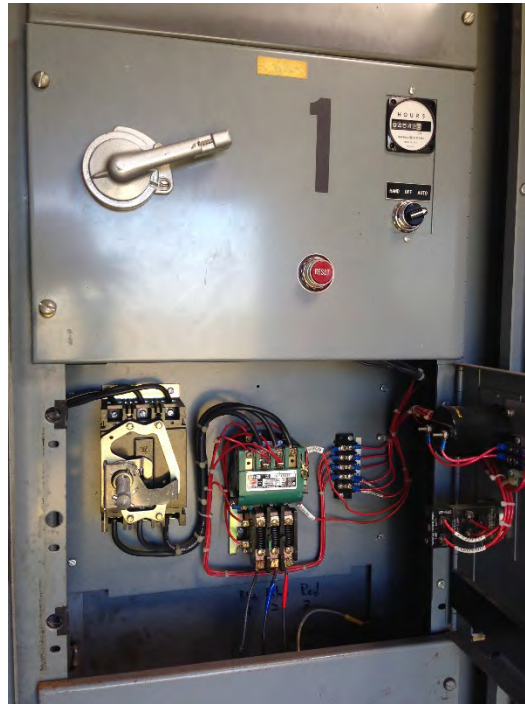
Figure 5: Treatment Ponds Motor Controller Compartment

personnel reported that reliability of the electrical equipment at this site has been very good and no operational issues currently exist.

The PLC panel at this site is essentially new and in very good condition. NMWD personnel stated that this equipment is working well and no operational issues exist at this time.

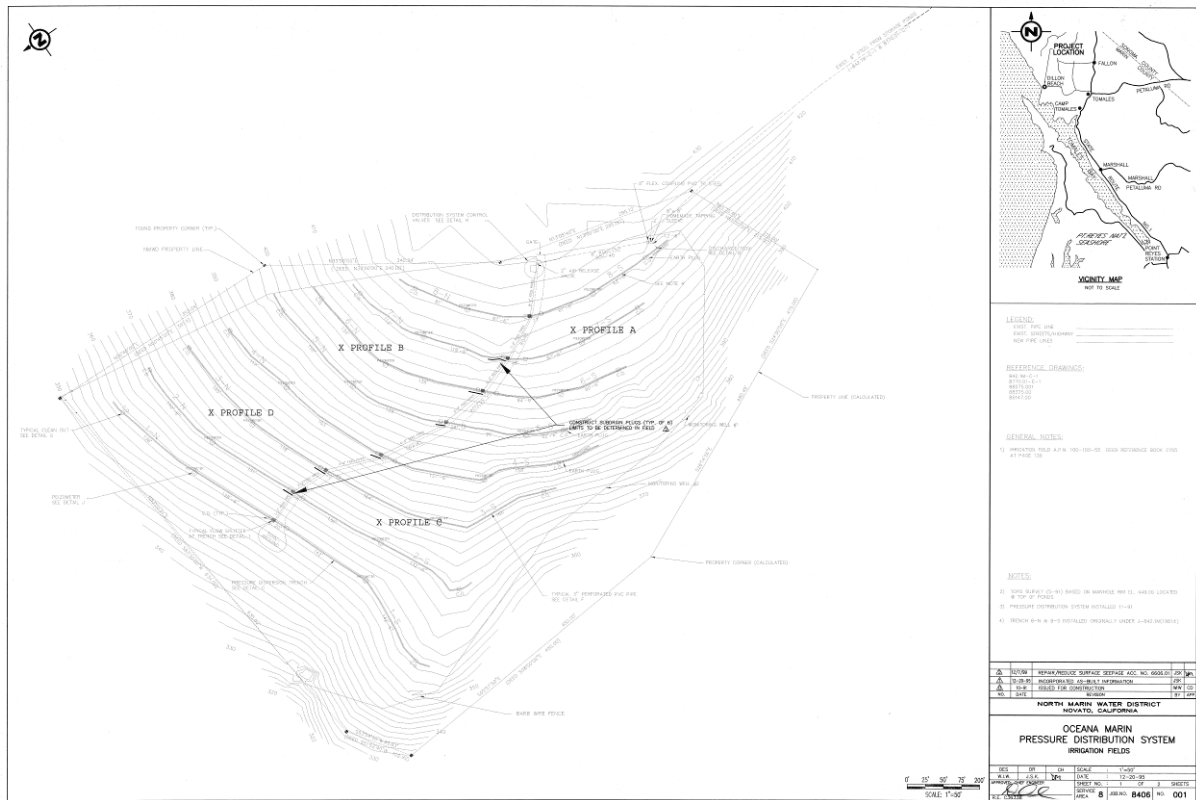
Profile A was excavated between drain line 7 and 8 on the South end of the field. The soil was found to have a high clay content very close to the surface and to the total depth of 72 inches. Mottling was noticed with 12 to 24 inches below grade which indicates that this area spends most of the year saturated. Typically areas with these conditions are not good candidates for use as dispersal fields. This may explain why line #8 is not accepting much effluent and is a good reason to abandon this line altogether.
