North Marin Water District

2015 MASTER PLAN UPDATE

Final Report

For the Oceana Marin Wastewater System

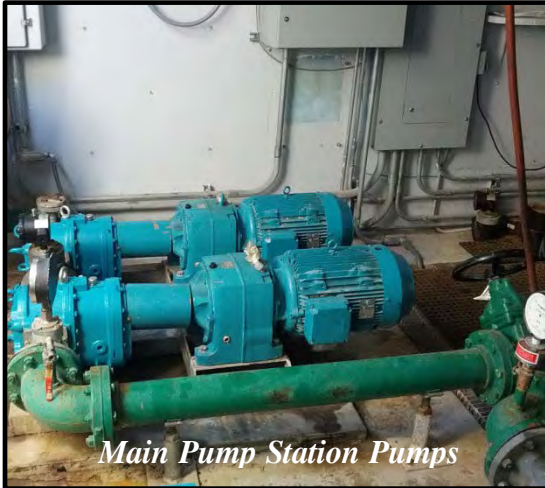
Doghouse Shed

The flowmeter is an Rosemont magnetic type with a 4" diameter flow tube, located in a pit outside the pump station. There is a single sump pump in the pump pit, which also contains the pump motors and critical electrical panels.

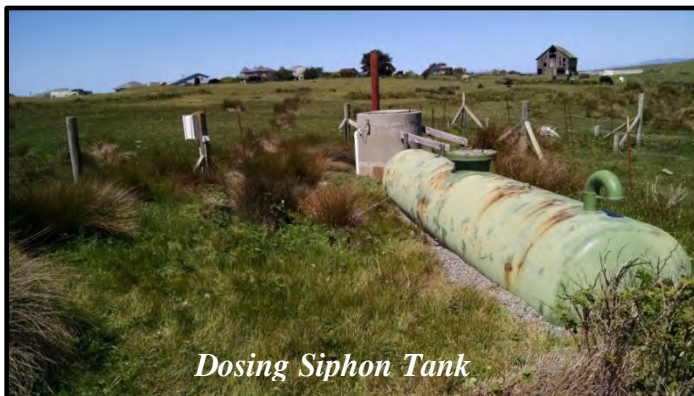
The Oceana Marin effluent disposal system consists of a pressure distribution/shallow gravel trench system. This type of system is suited for areas with high groundwater, steep slopes and low infiltration rates. Treated effluent is spread out over a wide area to enhance the infiltration and minimize the seepage to the surface. An automatic dosing siphon provides flow to the pressure distribution pipe network.

The disposal system was inspected on April 16, 2015 by Troy Pearce of AYS Engineering Group, Inc. The AYS report is included in Appendix G.
